SANDIA REPORT

SAND2014-20600

Empirically Derived Strength of Residential Roof Structures for Solar Installations

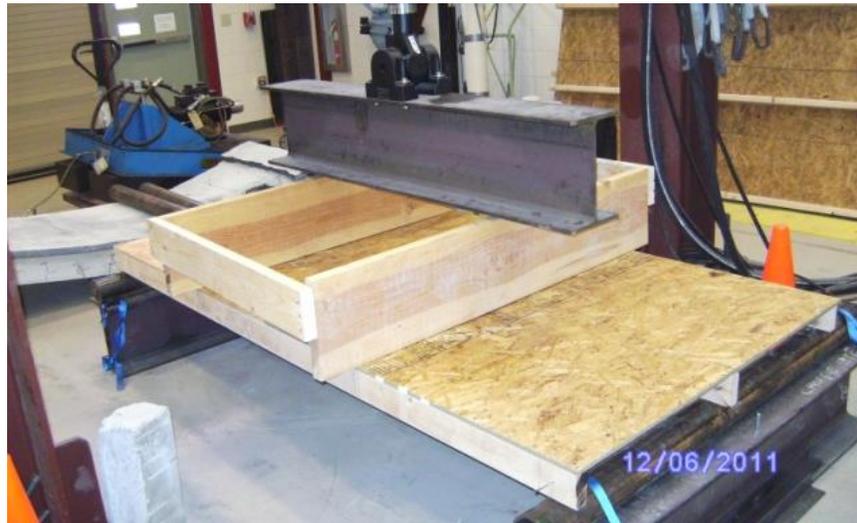
Figure 2. Photograph of test setup.

As a scoping exercise, three wood joist and structural sheathing assemblies similar to those commonly utilized in residential roof systems were loaded to failure in a four-point bending test. All of the assemblies consisted of three simply-supported 2"x4"x8' hem-fir joists visually graded as studs by the Western Wood Products Association (WWPA), spaced at 24" on-center. The Oriented Strand Board (OSB's) strong axis was oriented perpendicular to the longitudinal axis of the joists. Two of the three-joist assemblies had 7/16"x4'x4' OSB panels attached to the top of the joists, as shown in Fig. 2, leaving a 1/8" gap at midspan. One assembly was constructed with nailed joints and the other with glued-and-nailed joints (8d nails at 11.5" spacing, PL 400 Floor and Deck semi-structural adhesive) to connect the OSB panels to the joists. As a control, the third assembly consisted of three joists without sheathing. The support and loading geometry and the resulting cracking patterns for the three tests are shown in Fig. 3. The load was applied using displacement control at a rate of 0.10 in/min.

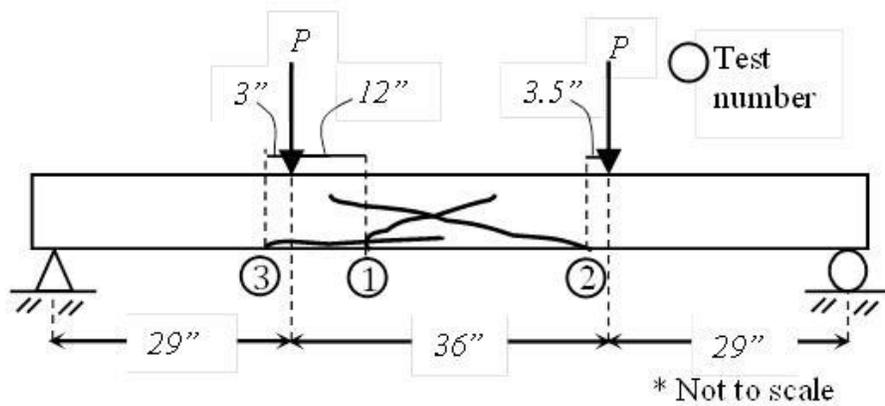
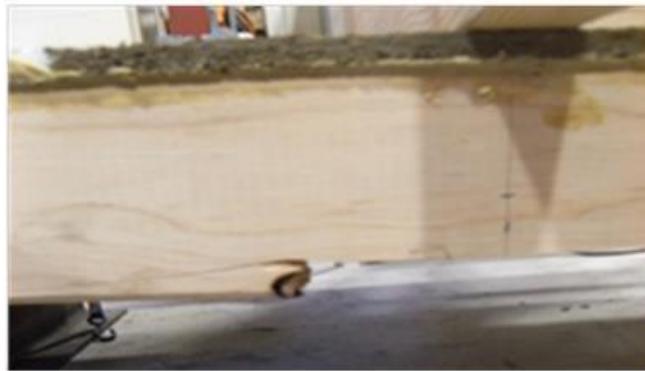
Figure 3. Sketch of cracks in tested joists, and photo of typical crack initiation at knot on tensile face of joist.

In all of the tested assemblies, only one of the three joists failed, perhaps because they were loaded under displacement control. The first joist to fail was always on one side of the assembly. Figure 3 also shows the locations of the cracks that initiated failure in each failed joist (in each case, initiated at the location of a knot on the tensile side of the joist) and their approximate trajectories.

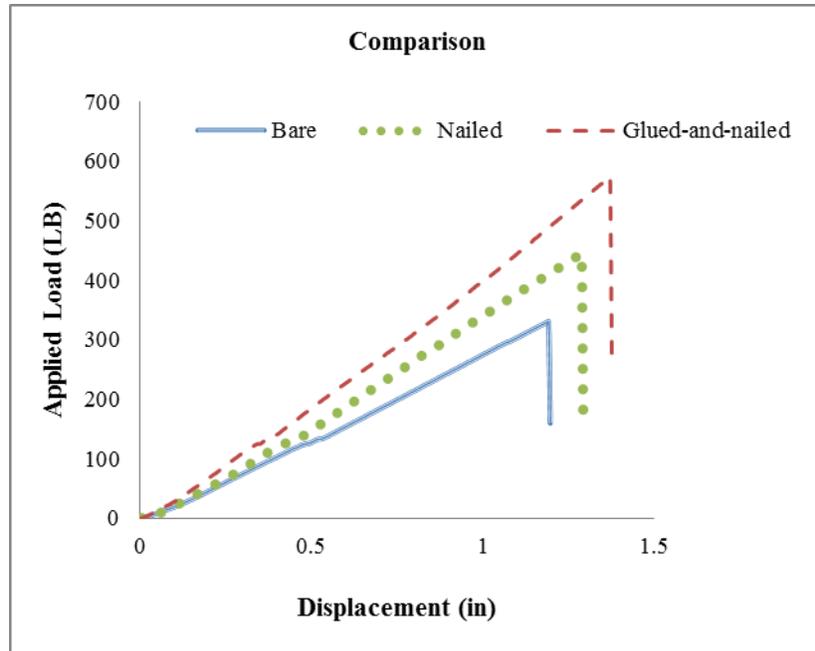
Figure 4. Comparison between loading-displacement relations of preliminary tests.

As shown in Figure 4, a load capacity increase of 73.4% for the glued-and-nailed assembly, and a 34.5% increase for the nailed-only assembly, relative to the bare-joist assembly, indicated an increased strength for the composite assemblies. Nonetheless, this increase in strength could be due to the high variability in the bending strengths of the joists themselves, and thus, a larger set of experiments was needed to determine whether this behavior was repeatable or not.

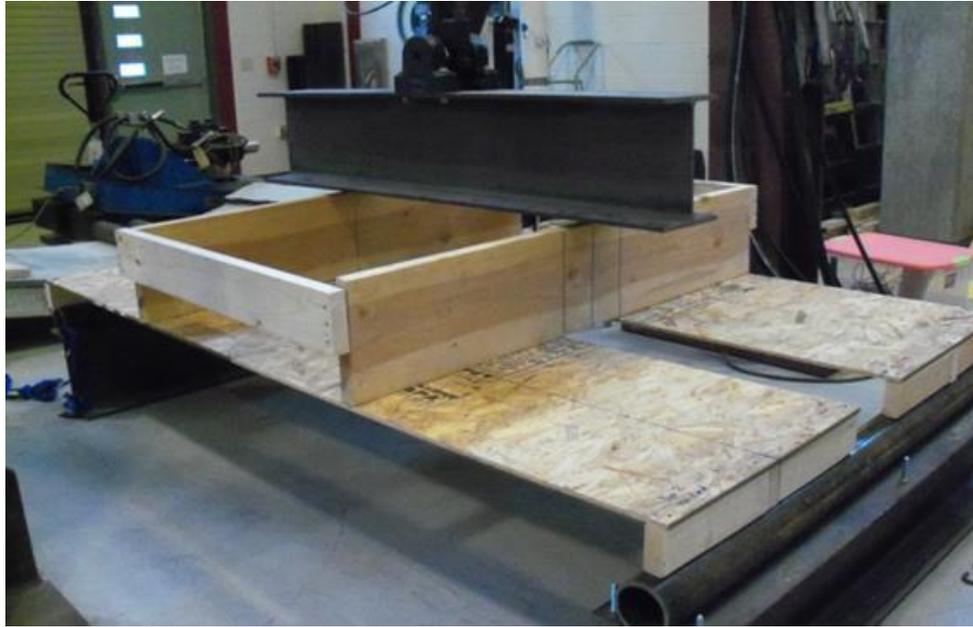
Figure 5. Second set test setup.

A set of eight flexural tests was performed to provide more data to better understand the results obtained in the preliminary exploratory tests. These specimens were slightly modified to avoid load sharing effects and to isolate the effects of composite action between the joist and the OSB. Each specimen consisted of one 2"x4"x8' joist (also visually graded as stud) with two 2'x4', 7/16" OSB panels attached on the top, to form a T- beam (with a 24"-wide flange and the same 1/8" gap at midspan), as shown in Figure 5.

Two bare joists and six composite joists (three with nails and three with nailed-and-glued connections, all on an 11.5" spacing) from a second batch of joists were carefully selected, with variable locations of knots along their spans. The hypothesis tested was that the location of the weakest point in the joist with respect to the location of the gap in the sheathing plays a key role in the effective bending strength of the joist due to partial composite action (PCA). The T-beams and the bare joists were loaded to failure with the same loading conditions as in the preliminary tests, as shown in Figure 5.

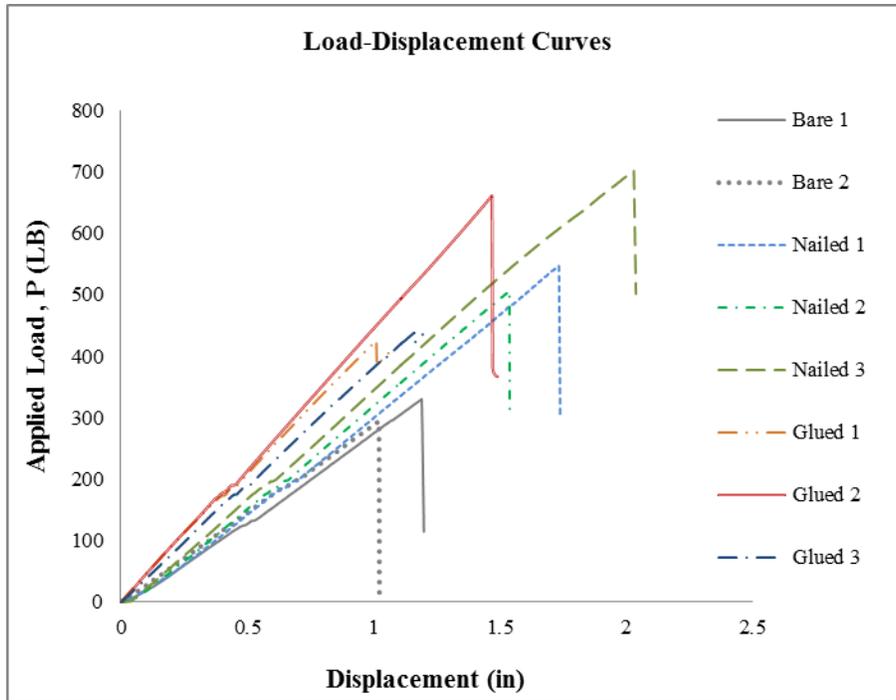
Figure 6. Load-displacement relations for tested specimens.

In this set of experiments, failure of two out of three nailed-only T-beams occurred in a region where a knot existed in the constant-moment region. There was not a knot in the third beam; instead failure initiated at the bottom of the joist three inches away from the gap in sheathing boards, resulting in a higher strength than in the case of joists with knots in the constant moment region. The load-displacement relation for all specimens demonstrated essentially linear behavior up to failure, as shown in Figure 6, indicating that an increase in stiffness (as the rigidity of the connection at the interface increases) does not necessarily mean an increase in strength. Also, in contrast to the results of the previous set of experiments, the strengths of the glued-and-nailed T-beams were not always higher than the nailed-only T-beams, as shown in Figure 6, although all six of the sheathed joists were stronger than the two bare joists. This variability in strength is attributed to the differing positions and sizes of the strength-controlling knots, among other factors.

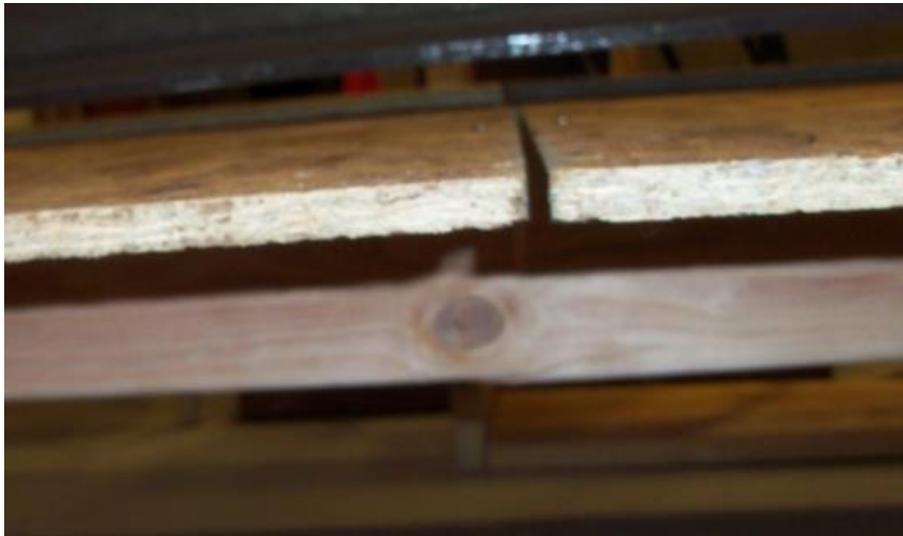
Figure 7. Knot at almost the same location as gap.

Figure 7 shows a 1.5" knot at less than 2" from the gap location in a glued-and-nailed T-beam, resulting in a much lower strength than a nailed-only T-beam. Note that a knot located directly below the gap would be the worst-case scenario in achieving any PCA in the T-beam as the gap plays a major role in the strength of the joist because the flexural stresses at the bottom of the T-beam at this location along the joist are highest.

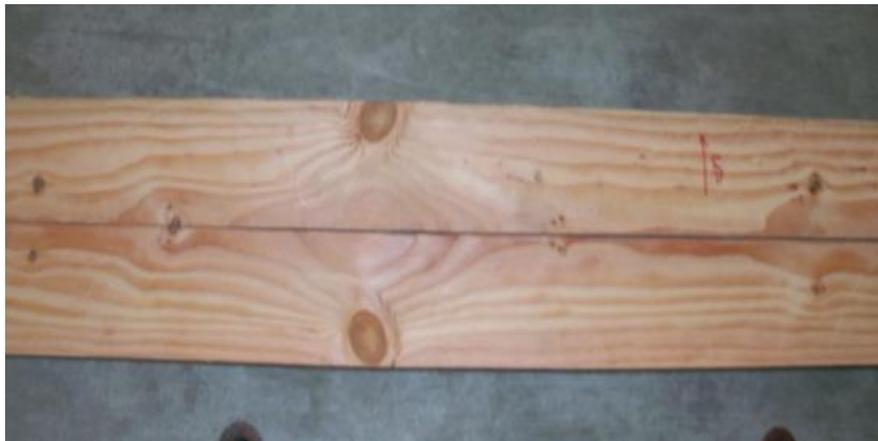
Figure 8. Twin 2" x 4" joists cut from a single 4" x 4" joist.

dimensions) joists into two 2"x4" nominal (1.5"x3.5" actual) joists, as shown in Figure 8, to produce the minimum difference in strength as both joists have nearly identical properties.

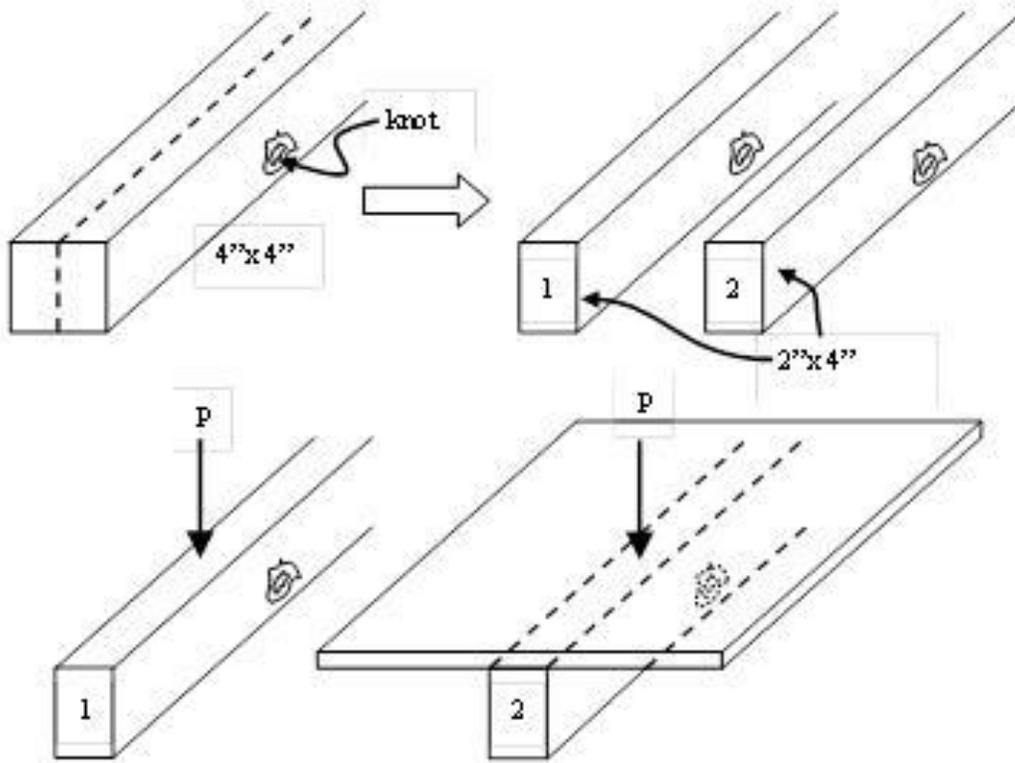
Figure 9. Schematic of the procedure for producing twin joists.

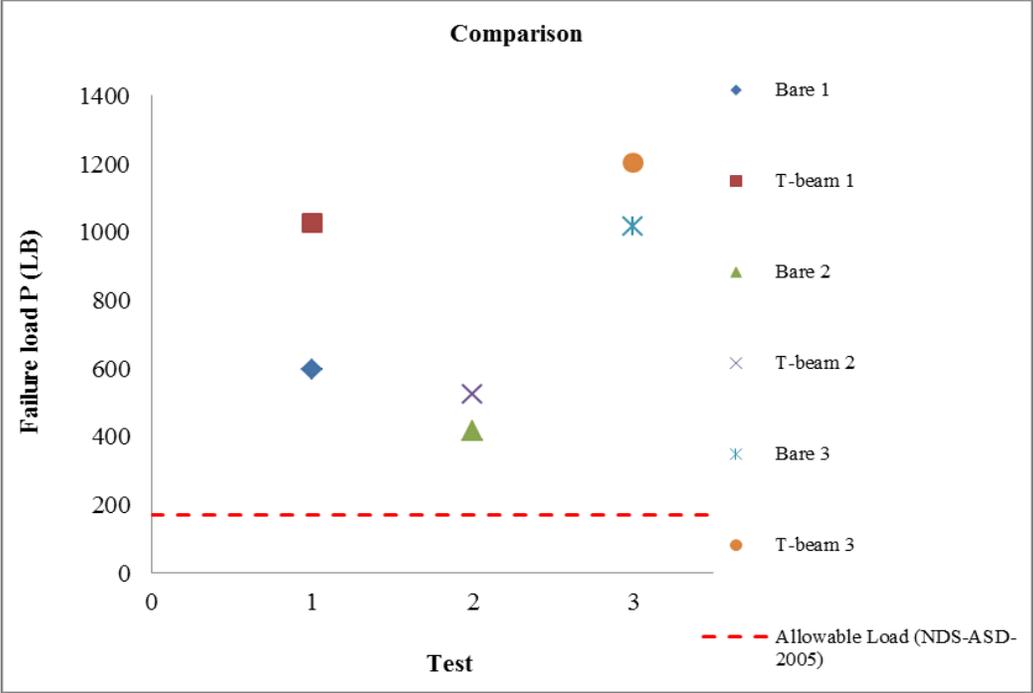
Figure 10. Failure load comparison between specimens.

The bare joist was loaded to failure first. Then the composite T-beam was loaded to the load at which the bare joist had failed and the gap opening was measured. Subsequently, the composite T-beam was loaded to failure. The failure loads, P , for all six of the tested specimens, are shown in Figure 10.

As shown in Figure 10, for each pair of 2"x4" joists, the composite joist was stronger than its non-composite twin. The load-displacement relations for the twin 2"x4" joists from test No. 1 are shown in Figure 11. An increase in stiffness as well as in strength is evident for the T-beam, compared to the bare joist. The readings from the dial gage at the location of the gap showed that the gap had completely closed when the T-beam reached its bending strength. This closure in the gap means that some continuity of the top flange was present and the OSB began carrying higher compressive forces, and hence, a larger percentage of the total external moment. Note that in all of the previous experiments (with joists with a lower structural grade), the joists failed before the gap could close. The higher the bending strength of the bare joist, the more likely the 1/8" gap is going to close completely, as the T-beam will have a greater curvature and a greater slip in the nails. The failure of both the bare joist and the T-beam occurred at the same knot in the constant moment region.

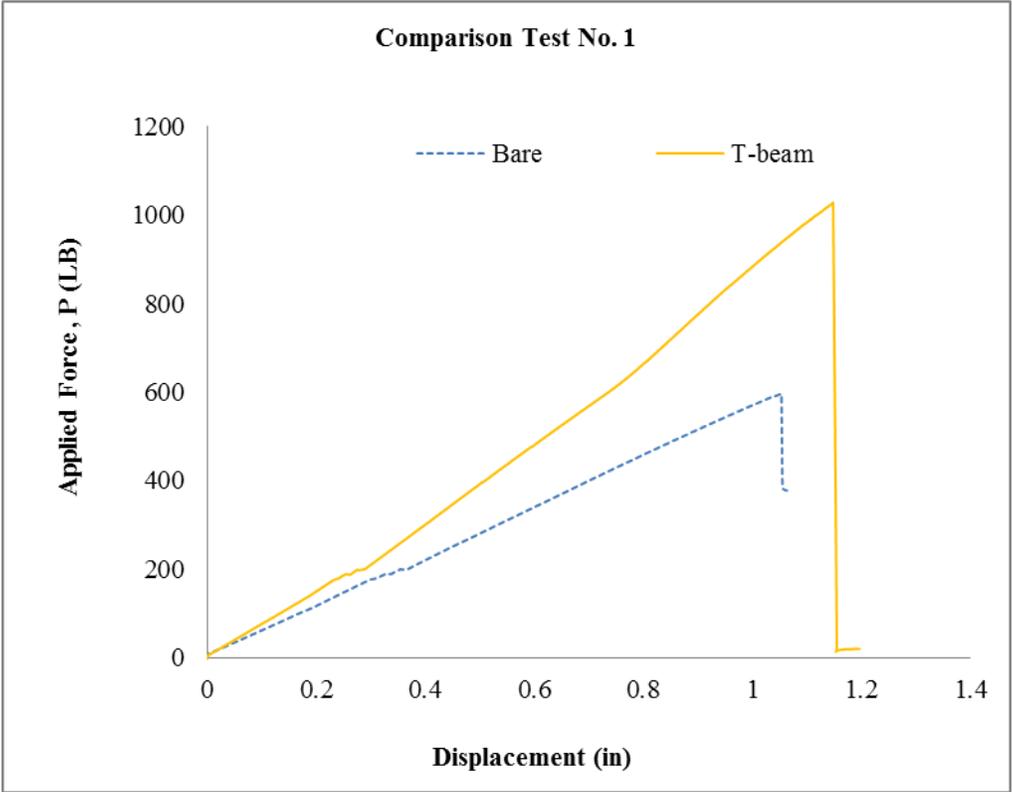
Figure 11. Load-displacement relations for test No. 1.

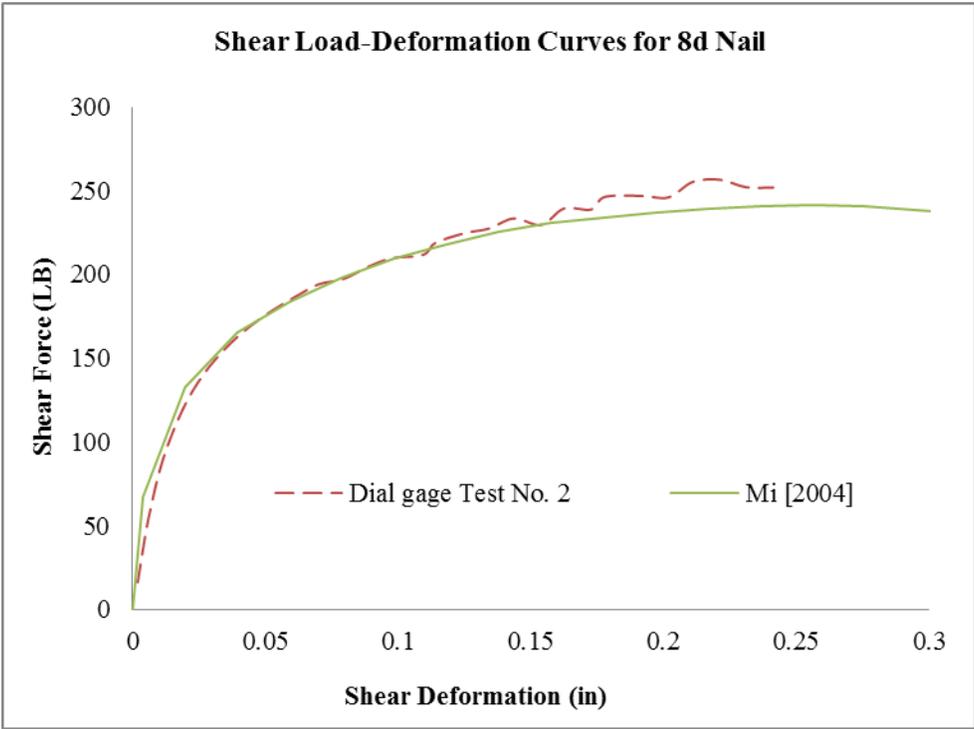
Figure 12. Shear load-deformation of one nail comparison.

Several researchers have tested joist-to-sheathing connections with different specimen configurations and parameters. Mi (2004) tested ten specimens of spruce pine fir (SPF), connected to 7/16" OSB panels with 8d nails, developing a multi-linear model for the shear load-shear displacement relation based in his test results. Mi's test setup was utilized in this research at constant moisture content conditions, altering only the species of the lumber (douglas-fir) with almost the same specific gravity as SPF and loading the specimen in compression rather than in tension. A comparison between the resulting load-displacement relations from the test and the multi-linear model developed by Mi, for one nail, is shown in Figure 12. As shown in this figure, the newly-obtained relation follows very closely the relation developed by Mi.

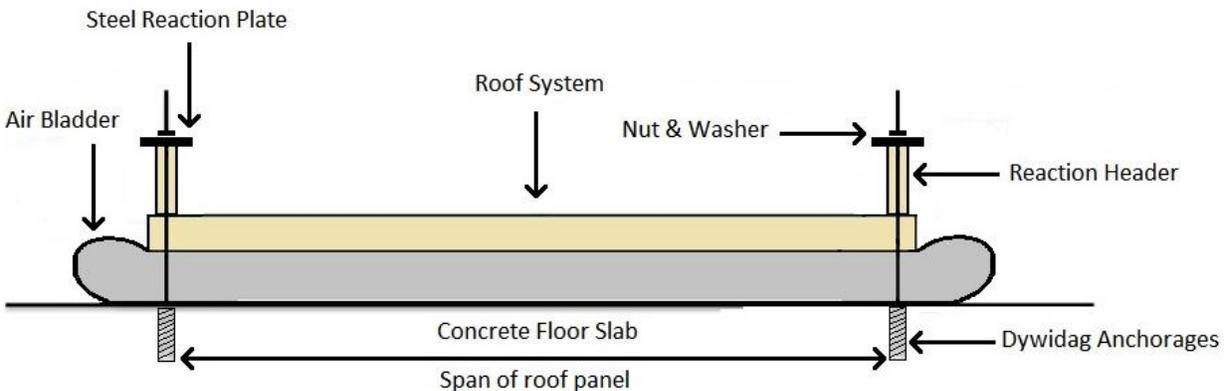
Figure 13. Side view schematic of laboratory testing (not to scale).

Air bladders were used to apply a uniform load across the full footprint of each scaled roof structure tested, as shown in Figure 13. Tests were performed on inverted test specimens. That is, the roof assembly's OSB surface faced the ground while the joists were on top. The air bladder was placed between the ground and the OSB surface of the assembly. As the roof assembly overlies the air bladder, a reaction header was placed on each end of the assembly to prevent the ends from displacing vertically, therefore acting in the same way as a bearing wall supports a roof. By allowing the air bladder to react against the ground, a uniformly distributed load equal to the air pressure in the bladder was applied to the inverted roof panel.

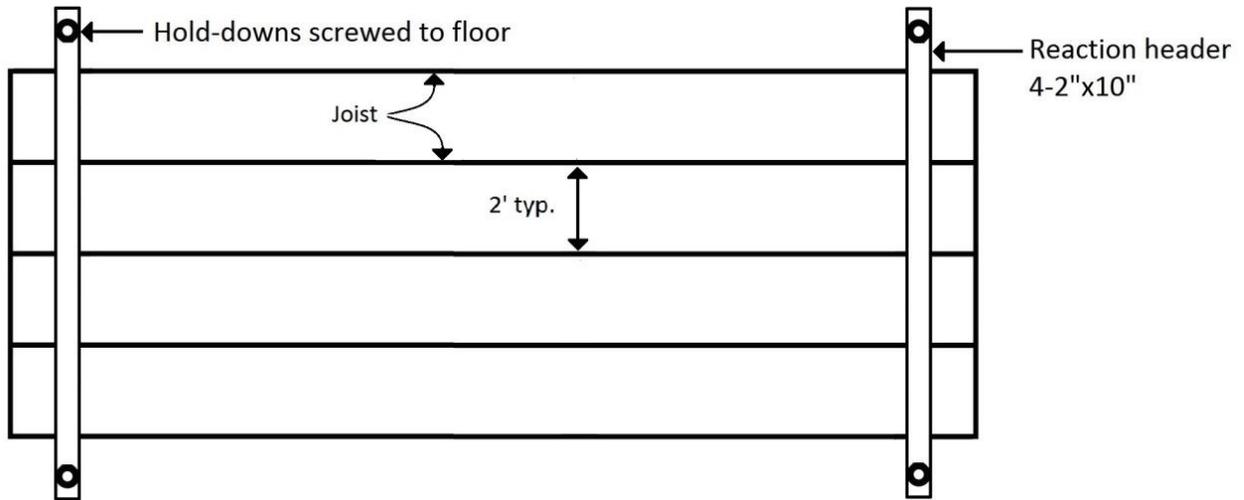
Figure 14. Schematic of laboratory test.

The construction of each roof assembly utilized five joists spaced at 2-ft on-center; the ends of each joist were then attached to like-sized end plates to complete a rigid frame (Figure 14). Once a roof frame was constructed, the frame was overlaid with 7/16" OSB decking as prescribed by the IRC (2009). The decking was then spaced 1/8" apart and nailed to the joist at 12-in on-center with 8d nails. All nails used in the assembly were collated 8d galvanized coated, clipped head nails, and were driven with a pneumatic framing nail gun. Air pressure in the nail gun was set to ensure nail heads were flush with the OSB surface.

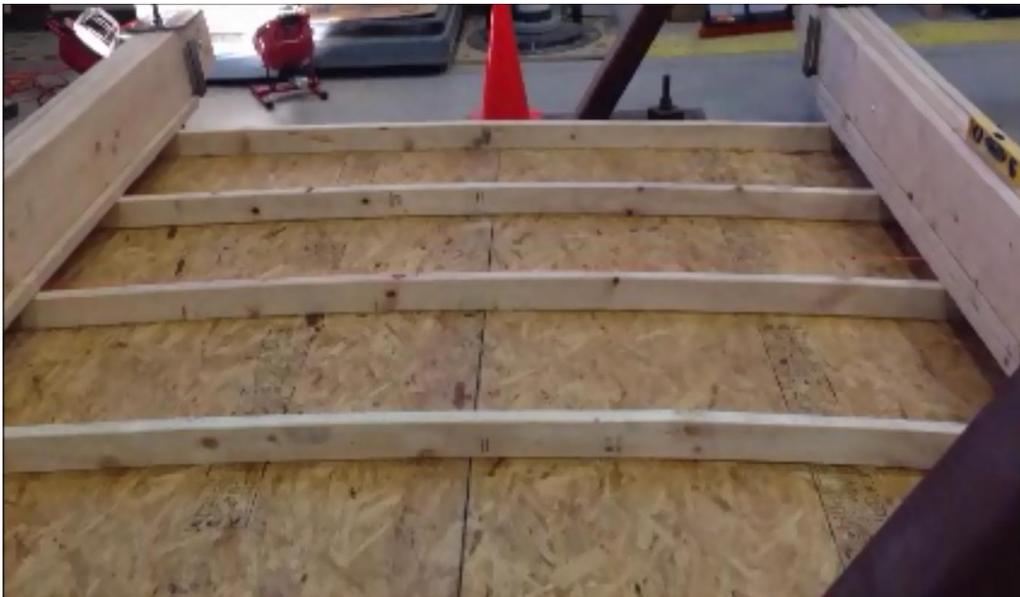
Figure 15. Photograph of roof assembly under load.

In preparation for a test, the completed assembly was inverted and set on top of the air bladder. The reaction headers were then placed above the assembly. All dimensional lumber and OSB decking was purchased from a local lumber retailer (Home Depot). Figure 15 provides a photograph of a roof assembly under load.

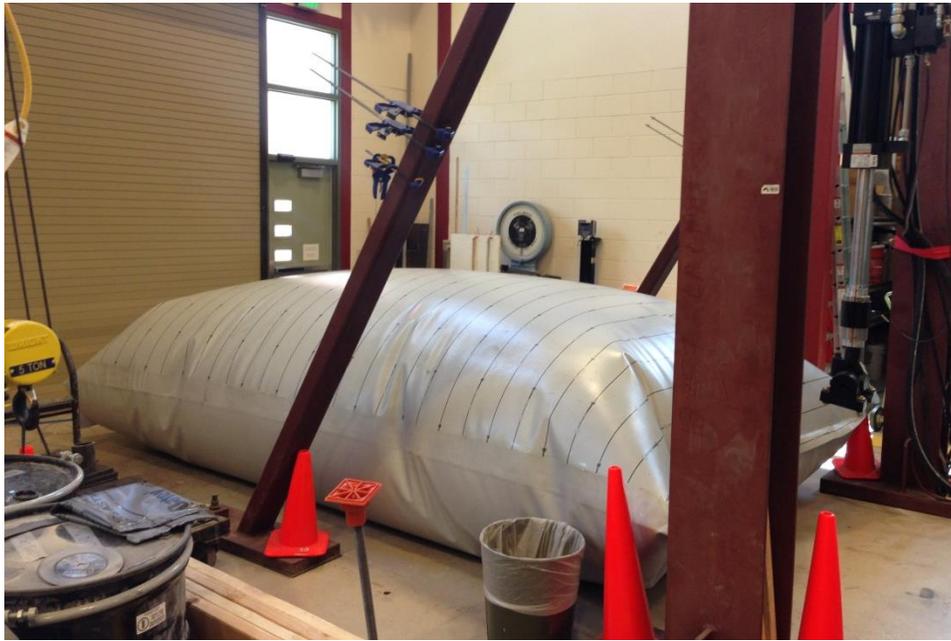
Figure 16. Photograph of 10' x 16' PVC air bladder.

Air bladders were custom built for each test assembly plan area utilizing 40 mil PVC sheets glued together with PVC adhesive. Figures 16 and 17 show photographs of two of the PVC air bladders used.

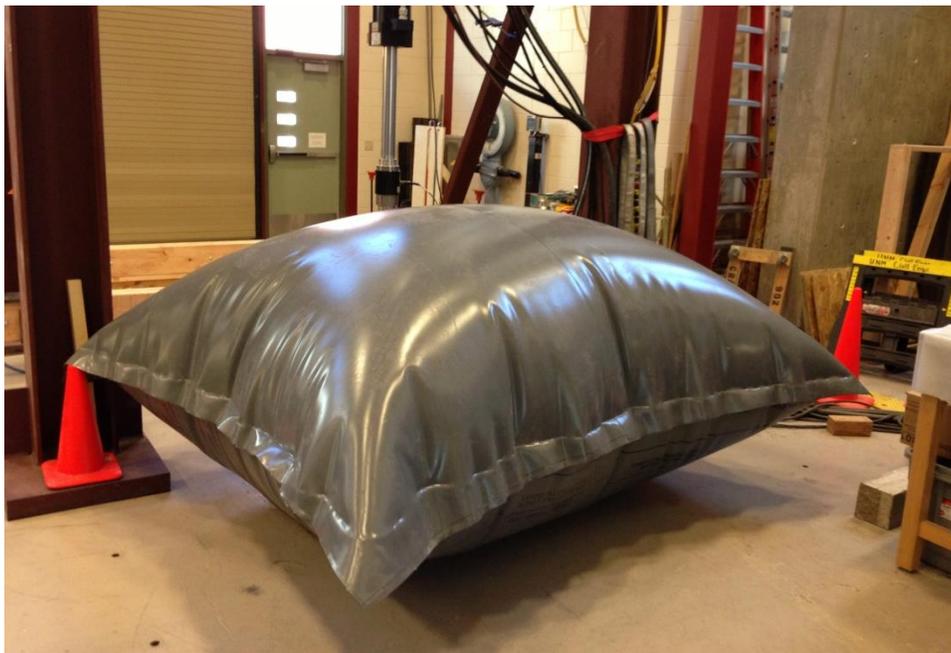
Figure 17. Photograph of 8' x 10' PVC air bladder.

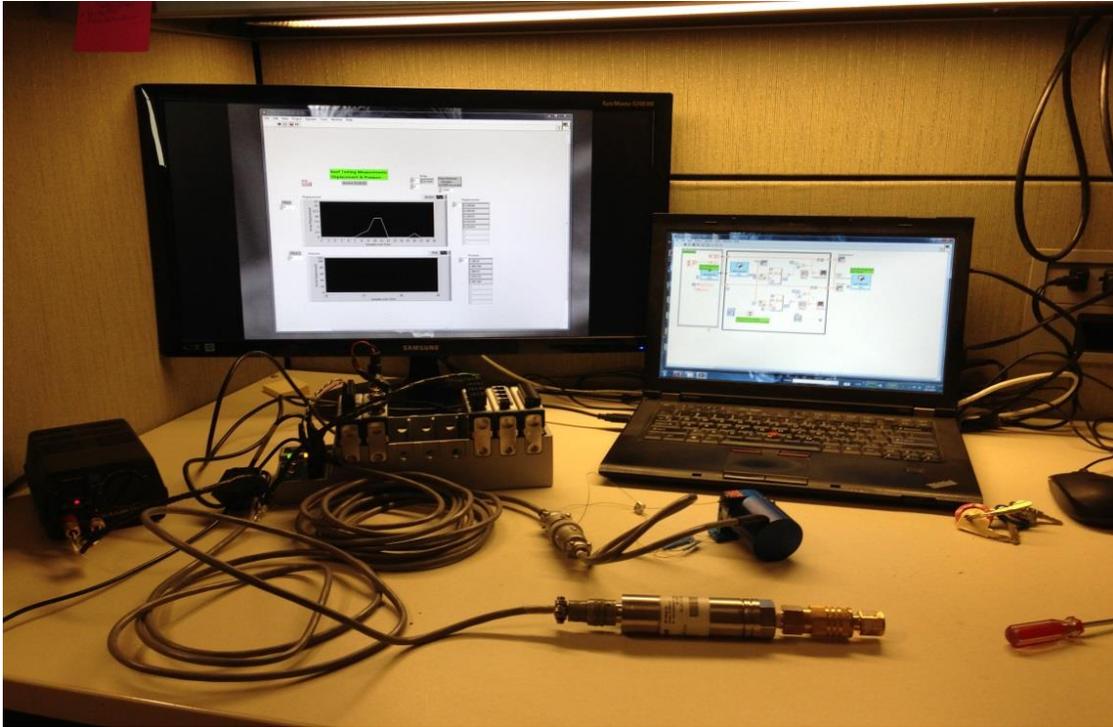
Figure 18. Digital data collection system.

Both manual and automated digital data collection systems were utilized to measure pressure and displacement at the test assembly center. Real-time digital data acquisition was accomplished using a National Instruments eDAQ in conjunction with LabVIEW software. Pressure

measurements were gathered with a Honeywell pressure transducer, while displacement was monitored through the use of a Firstmark Controls yo-yo potentiometer. Figure 18 provides a photograph of the digital data collection system.

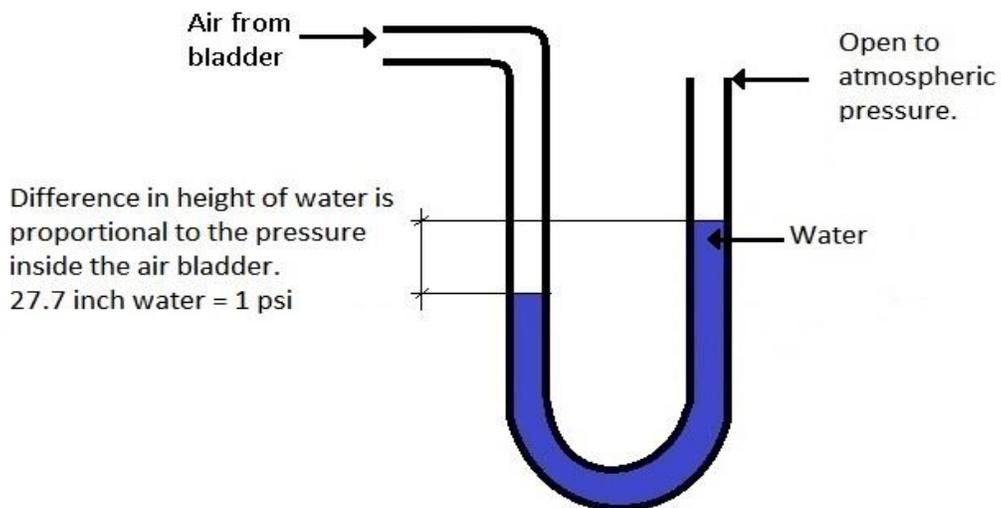
Figure 19. Manometer

During air bladder inflation, pressure was monitored using water column manometers as shown in Figure 19 and 20.

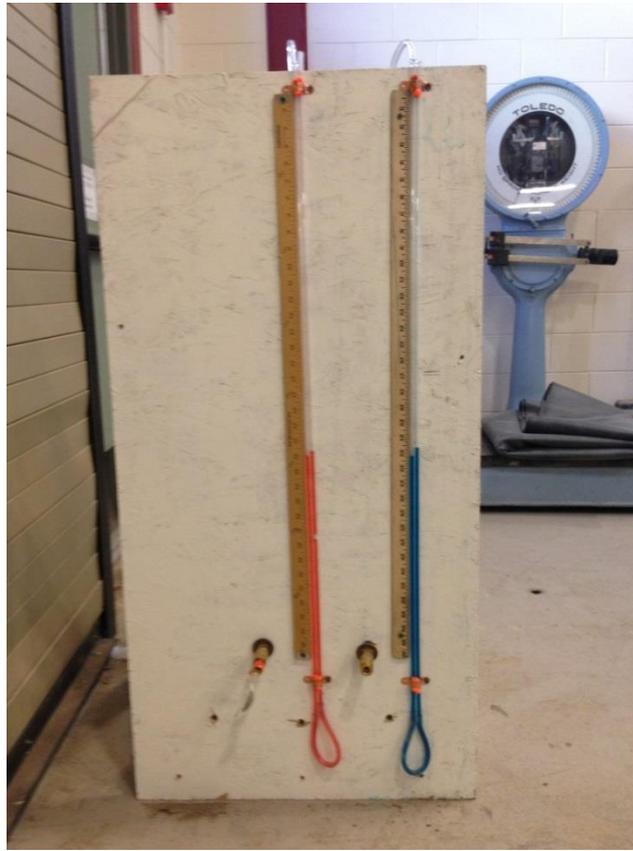
Figure 20. Photograph of double manometer use in laboratory.

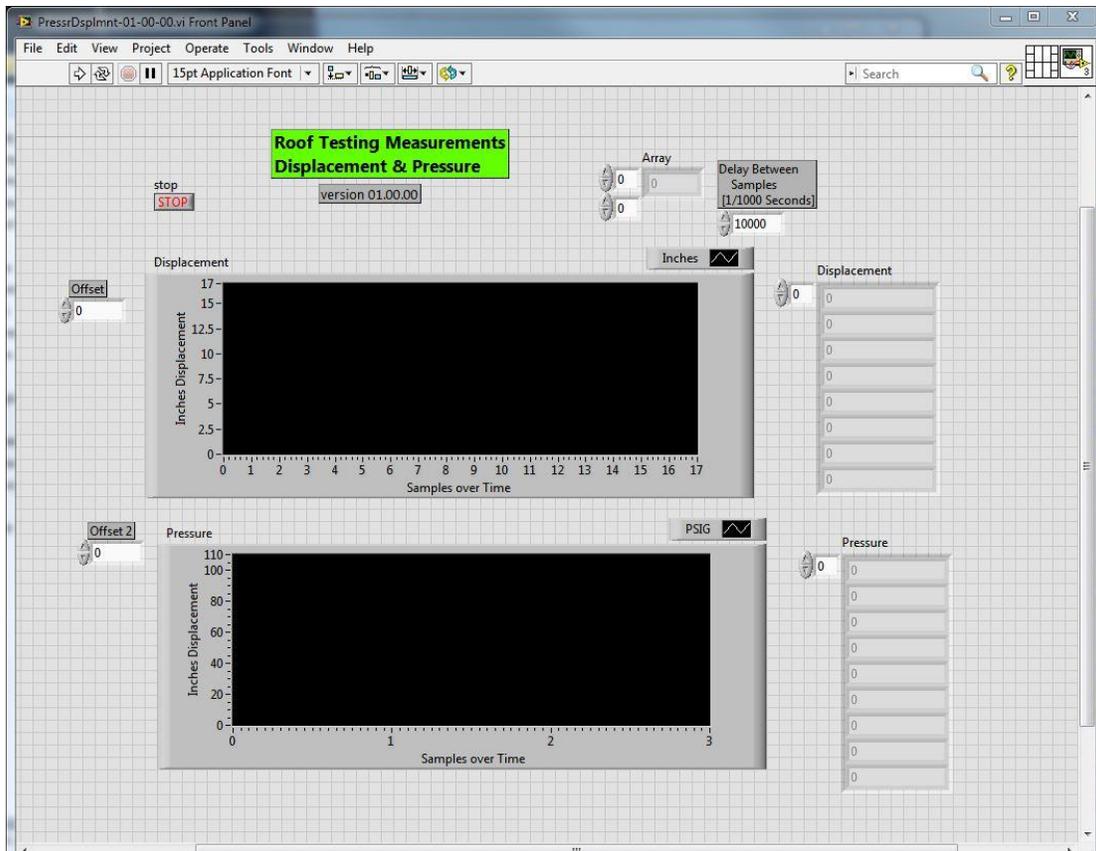
Figure 21. Real time testing display data.

During the testing of the assemblies, deflection and pressure were monitored as a function of time. Due to the loading configuration, the center of each span experienced the largest deflection. A graphical user interface was built with LabVIEW to monitor the data in real time allowing for both data logging and real time verification of results. A Fluke 189 data-logging multimeter was also utilized to add a layer of redundancy to the data acquisition from the pressure transducer. It is of interest to note that a multimeter can be used to monitor and subsequently record the change in voltage of a transducer; this change in voltage can then be converted to a change in pressure or position through appropriate calibration procedures. The multimeter was set to acquire a measurement every five seconds. The results were then converted to a pressure measurement and compared to the measurements made by the National Instruments eDaq system. Data collected from the two instruments were nearly identical providing added confidence to the data acquisition accuracy. Figures 21 and 22 show the graphical user-interface and underlying LabVIEW data acquisition program.

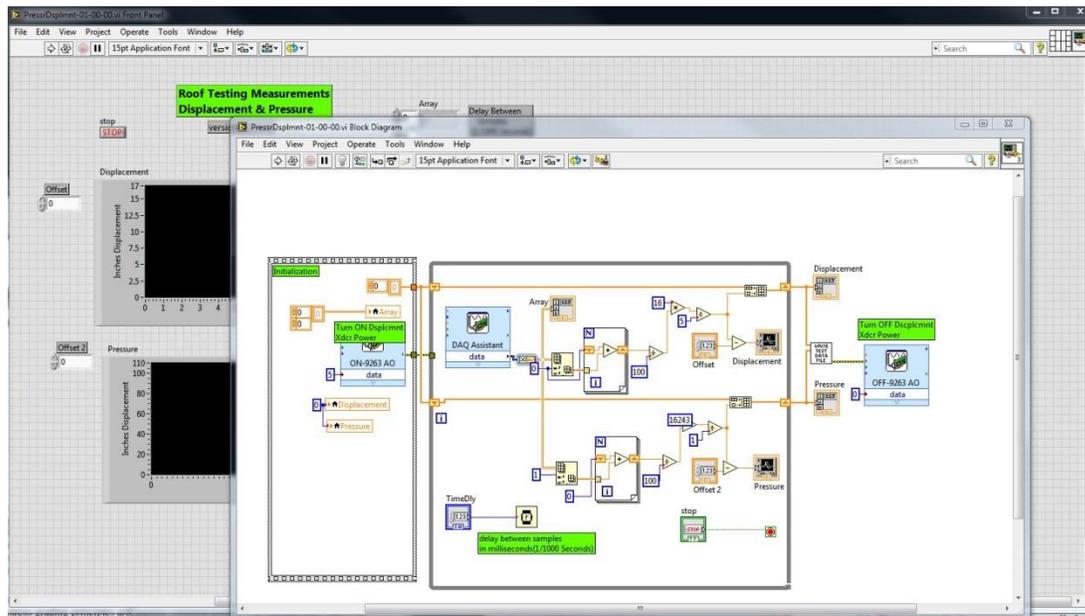
Figure 22. LabVIEW program used in data acquisition.

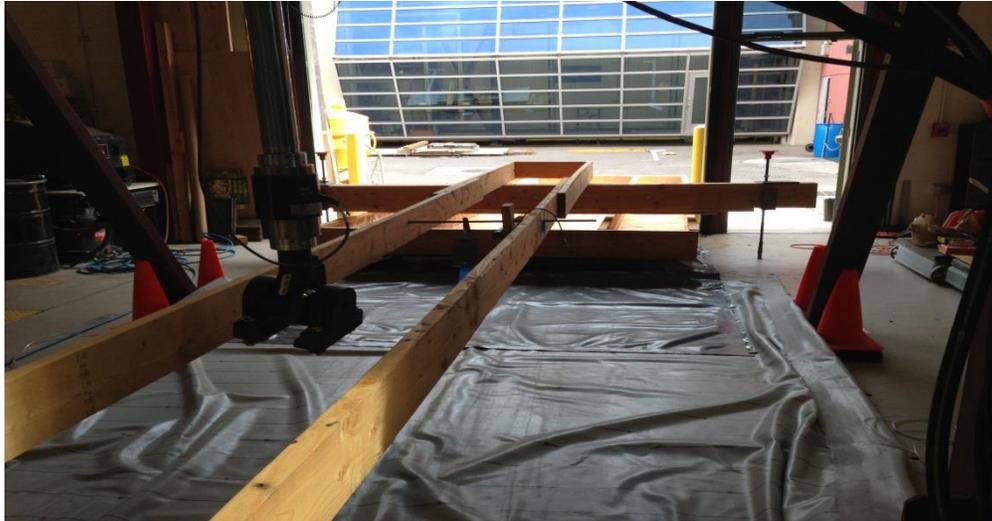
Figure 23. Photograph of assembly being rolled onto air bladder.

For each test, reaction headers were set at the appropriate distance to accommodate the chosen span. After the reaction headers were in place, the assembled inverted roof panel was positioned using rolling dollies into testing position above the bladder and below the reaction headers. Next, the test assembly was clamped to the headers suspending it above the bladder to allow for perfect bladder inflation. Figure 23 shows a photograph of an assembly being rolled under the reaction headers.

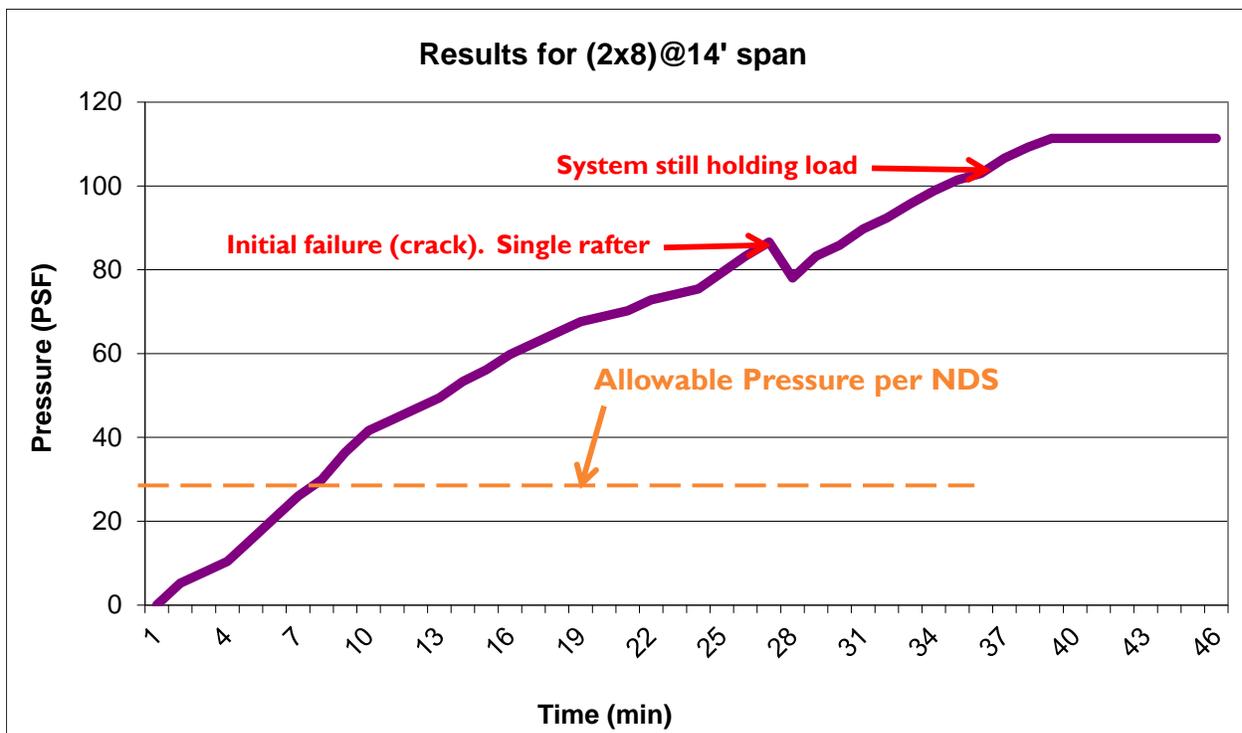
Figure 24. Typical failure curve for roof assembly.

A typical failure load curve can be seen in Figure 24. Failure of the first structural member allows for a decrease in pressure and thus identifies failure for the test assembly. It can be seen however, that failure of the initial structural member does not necessarily constitute system failure. The roof assembly generally would allow for pressure buildup well beyond the initial failure point. Testing generally stopped when the deflection became too large for the test apparatus.

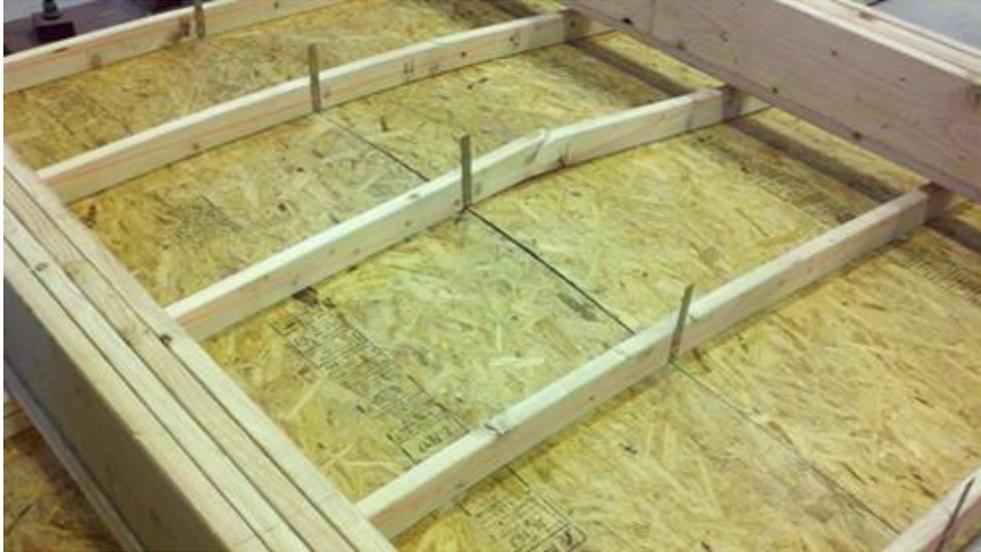
Figure 25. Typical failure in rafter, most occurred in center.

Typical member failures during testing are shown in Figures 25 and 26.

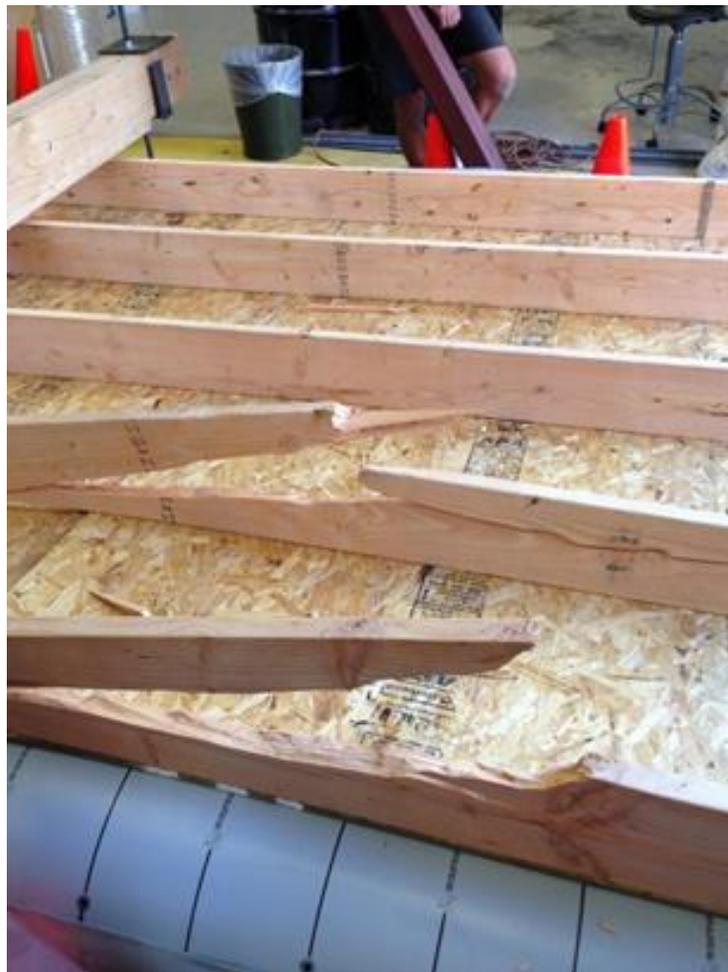
Figure 26. Failure in rafter, some occurred in side rafters.

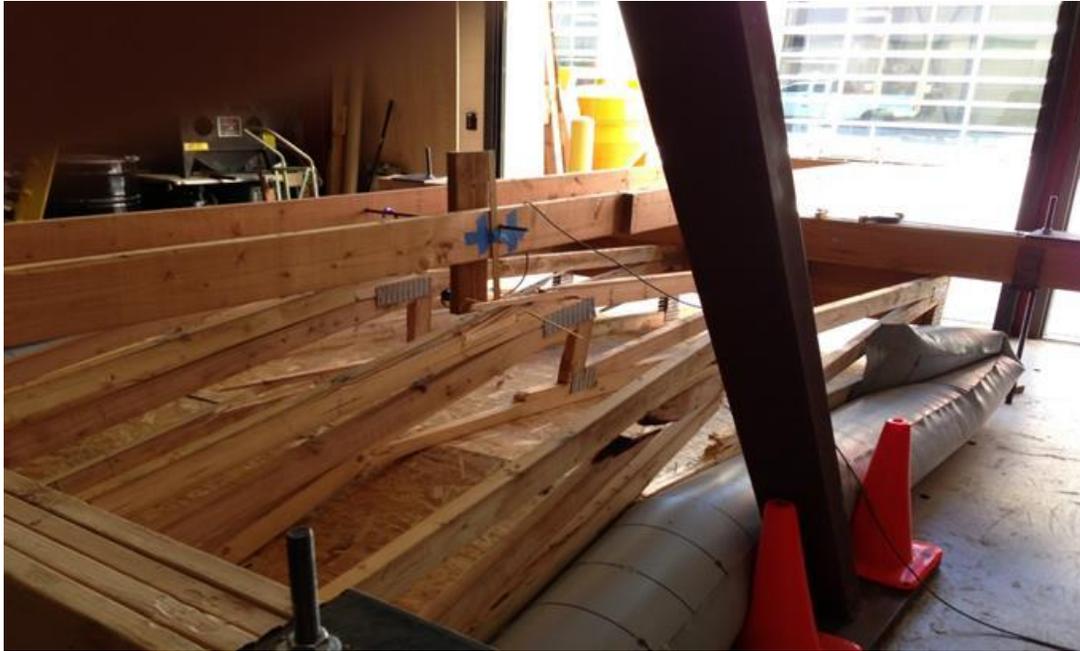
Figure 27. Failure in open web (web member) truss roof test assembly.

Failure in open web trusses occurred in truss members (Figure 27) as well as joint connections (Figure 28). Failure produced an immediate, permanent loss in load carrying capacity.

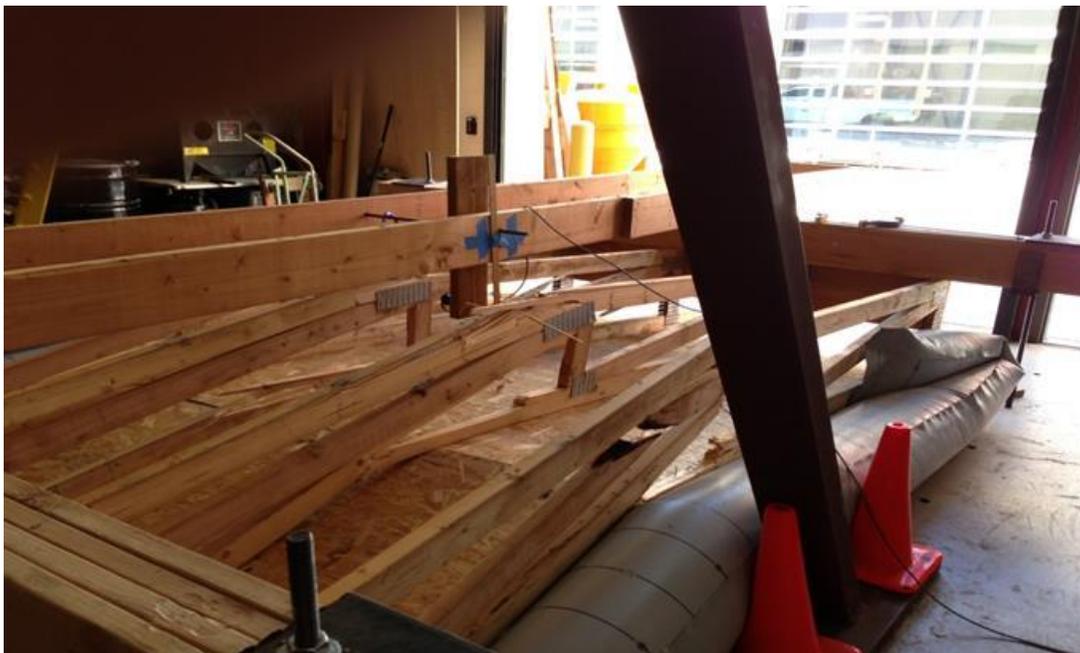
Figure 28. Failure in open web (member connection) truss roof test assembly.

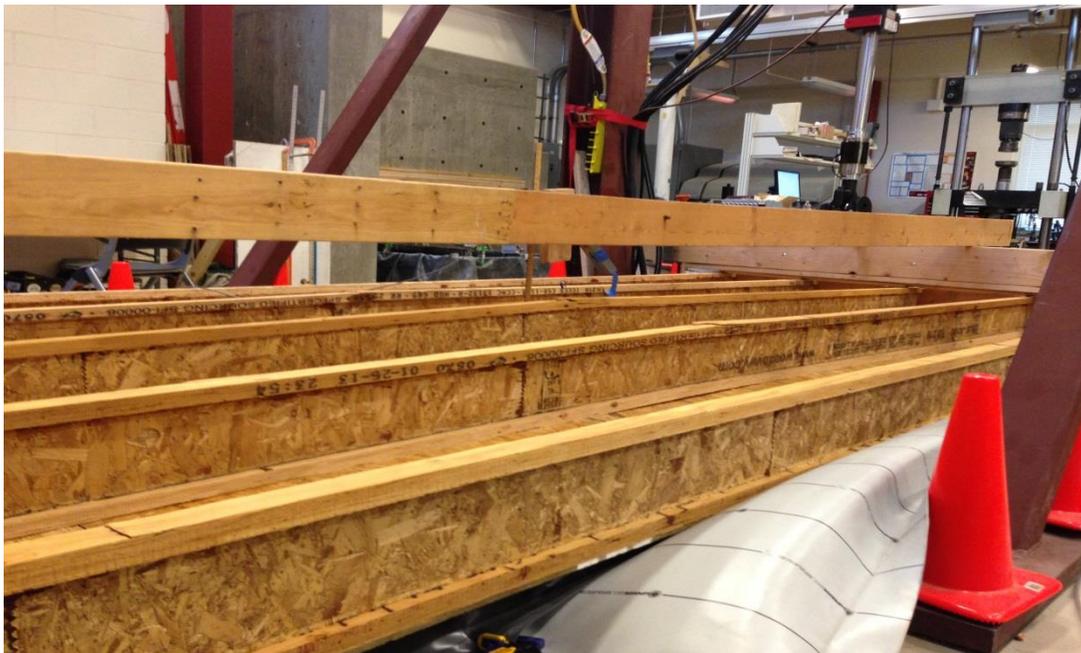
Figure 29. Failure in TJI roof test assembly.

Trus Joist (TJI) is the company that developed the wooden I-joist 50 years ago. The product is a fabricated wooden joist engineered to provide strength and stability. The I-joist is light weight and comes in long span lengths. A series of tests featuring TJIs were performed similar to the dimensional lumber testing. The failure mode was very consistent in that the top chord generally failed first. Furthermore, the beam strength is very consistent (Table 5). During several of the tests the top chord of multiple TJIs failed simultaneously (Figure 29).

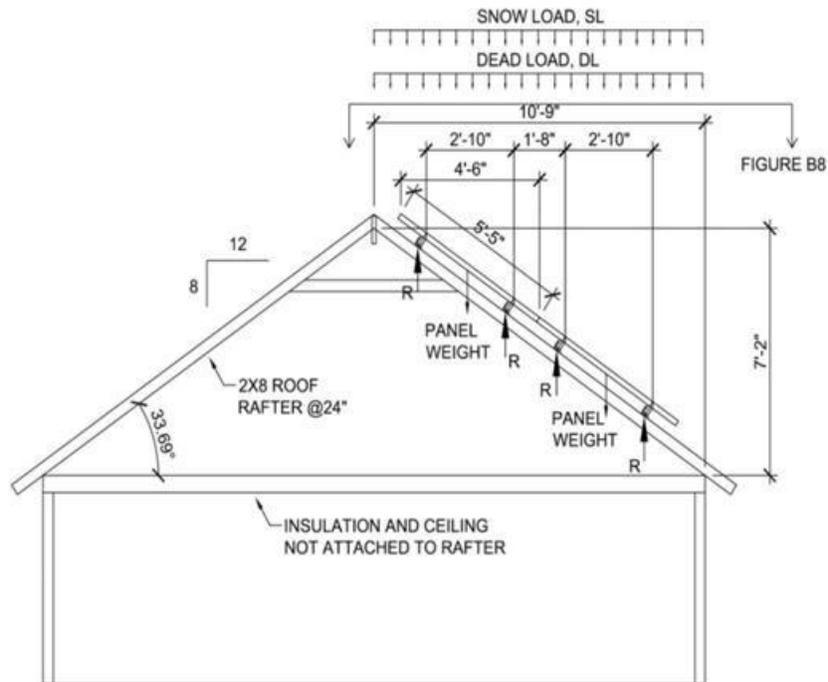
Figure 30. Example of loads applied to rooftop per ASCE 7-10.

The typical analysis methodology chosen by structural engineers nationwide to evaluate a given roof structure is to analyze a single beam or truss and extrapolate that strength across the roof. The engineer will assess the prescribed loading on the roof based on the national structural engineering code (ASCE 7-10) and apply the designated loads at the geographically suggested rate (Figure 30).
